Dunbar Spring Neighborhood Walkability Assessment Report

(August 2014)

WALK REPORT
2014

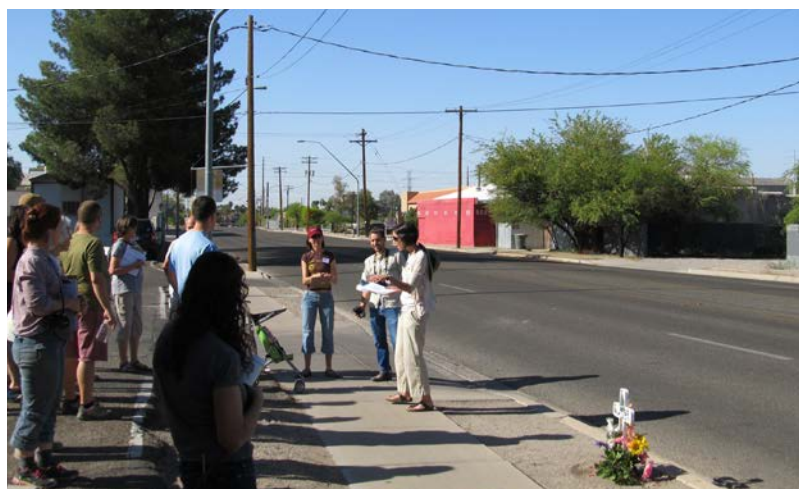
Main Avenue

Walk & Talk discussions on this segment were primarily focused on the possibility of implementing a road diet along Main to make room for bike lanes and to provide easier crossings for pedestrians. Most participants agreed that crossing Main can be challenging depending on vehicular traffic. Improvement ideas shared include: marked crosswalks (especially on 1st Street by Estevan Park), pedestrian refuge islands, HAWK lights, a road diet with a parking lane buffering a bike lane, water harvesting tree basins to create a tree-lined sidewalk buffered from traffic, and a better entrance to Estevan Park.

Safety ratings were slightly skewed towards the positive end including six marks as *safe*, four as *unsafe*, three as *somewhat safe* and one each as *very safe* and *very unsafe*. Safety was largely attributed to sidewalks, followed by low volume of traffic and streetlights. Lower safety scores were primarily explained by crossing challenges, followed by too many traffic lanes, speeding, and excessive solar exposure.

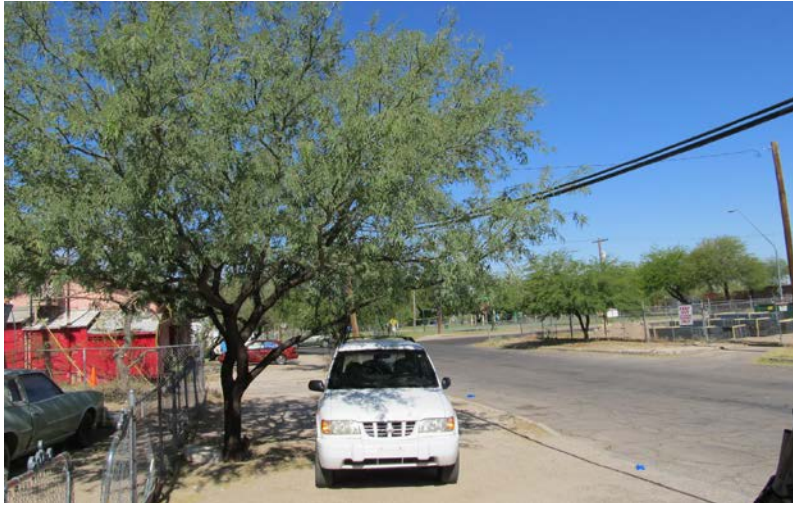
Unpaved pedestrian area blocked by a parked vehicle

Safety ratings were pretty evenly distributed across the lower and the higher ends of the scale, with Segment 2 receiving three marks as *somewhat safe*, five as *unsafe*, four as *safe*, and one as *very safe*. Higher scores were generally associated with slower traffic and a decent clear area for walking, but also with quiet neighborhood streets, as well as high use and visibility. Lower scores were mostly due to lack of a sidewalk/path, followed by industrial feel/lack of eyes on the street, lack of trees, trash, scary dogs, homeless people, and cars turning from Main.

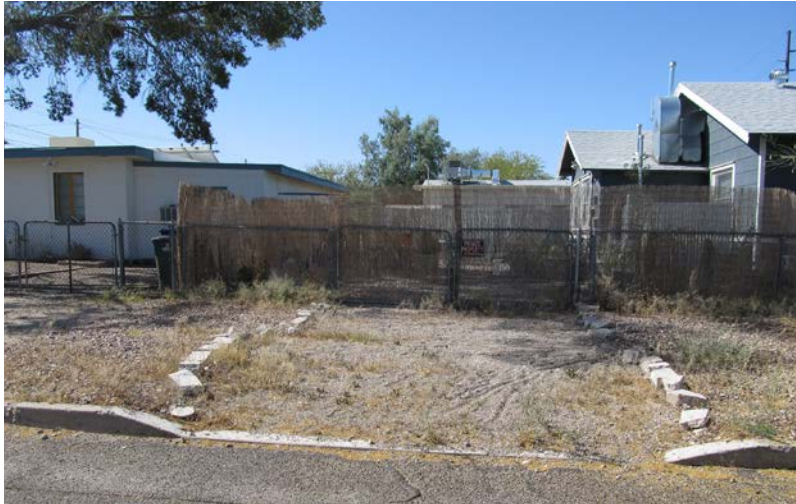
Segment 3: 1st Street between 11th Avenue and 10th Avenue

Many participants felt that the gravel between 11th Ave and Queen did not present a comfortable walking surface. One of the neighborhood residents brought a stroller along to test the difficulty of walking off the street and the stroller had to be lifted and carried in this area due to the large gravel. Speeding was also pointed out as an issue, along with the need for traffic calming integrating water harvesting for trees. One person shared that a previous proposal for a traffic circle was met with concern by a nearby neighbor due to flooding on this street. Residents liked the idea of a bike/pedestrian path in the street protected by on-street parking.

Gravel surface and rocks blocking passage

This segment received six ratings as *safe*, five as *somewhat safe* and three as *unsafe*. Safety was attributed to slow cars, neighbors, and a partial sidewalk in front of the church property, while lack of sidewalk/path, the gravel surface, rocks creating obstructions and trip hazards, and traffic concerns related to wide street width, fast traffic, and no traffic calming were listed as negative observations.

paths clear and maintained and using more pedestrian-friendly materials such as dirt, stabilized earth, crushed stone, etc.

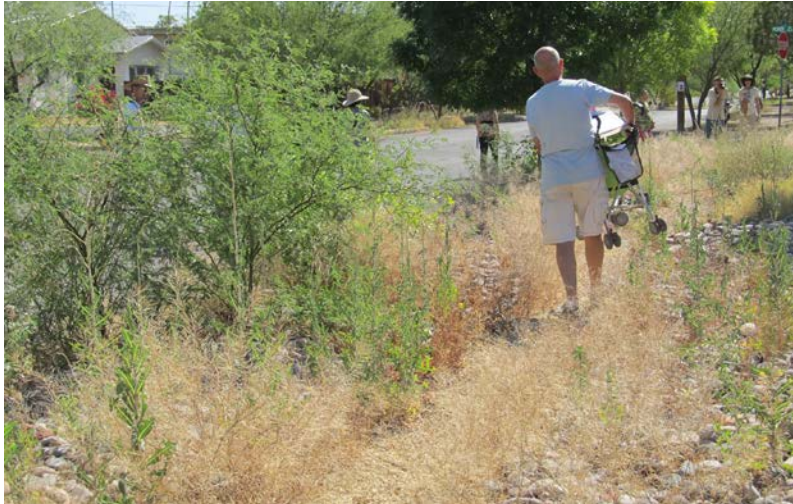
Gravel path taken over by vegetation

There was mixed feedback about the safety of this segment, including three responses rating it as *unsafe*, two as *somewhat safe* and one each as *safe*, *very safe*, *very unsafe*. Similar to the previous section, safety was associated with slow cars, being on a neighborhood street, and having more people on the street. Other people perceived the traffic conditions differently and picked a lower safety score based on speeding cars, lack of traffic calming, and wide street width. One person highlighted the positive safety impact of open porches and see-through fences vs. the negative impact of high fences blocking the “eyes on the street” along the block. Narrowness of the path, lack of ramps, and the gravel surface were also listed as safety concerns.

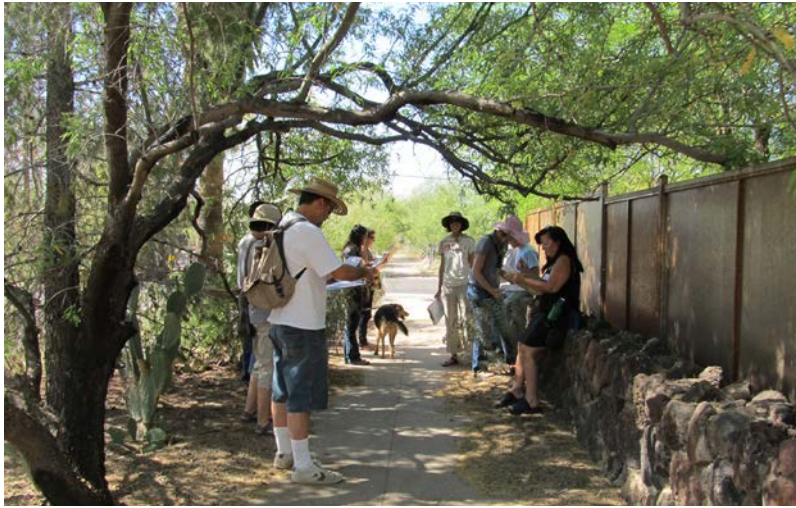
Dense shade canopy over the sidewalk

Safety scores for this segment were very high, with seven marks as *very safe* and four as *safe*. Respondents primarily emphasized shade/landscaping/trees buffering the street from the sidewalk, but several people also made reference to the friendly and neighborly feel of the street and interactions with neighbors as well as interesting and attractive homes. The only negative remarks noted on the uneven sidewalk surface in places.

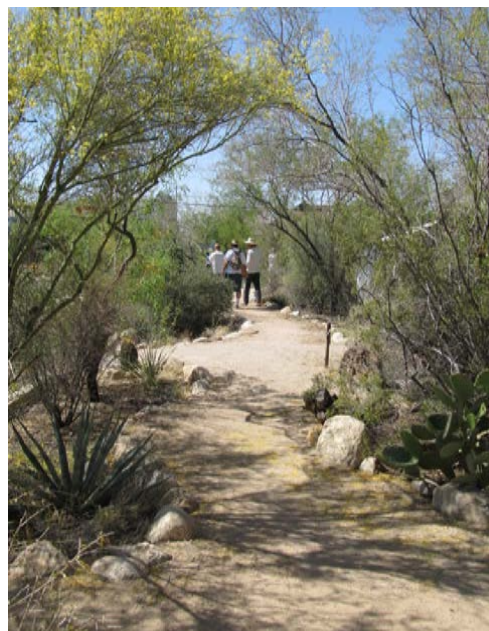
Compacted soil path with landscaping

This segment was rated *unsafe* by two people and *somewhat safe*, *safe*, and *very safe* by one person each. Negative comments regarded encroachment in the right-of-way, trash cans in the walking path, and the impervious wall at the SW corner of 9th and University, while positive comments mentioned nice homes and mature landscaping. One respondent noted that the west side was “unwalkable” due to the wall and other obstacles blocking the pedestrian area.

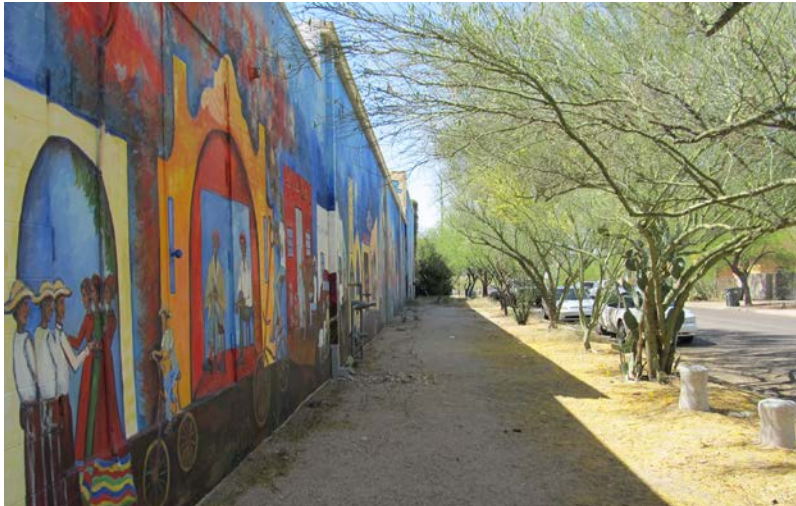
East side

There was mixed feedback on comfort and welcome measures, including two as *somewhat comfortable/welcoming* and one each as *very comfortable/welcoming*, *comfortable/welcoming*, and *uncomfortable/unwelcoming*. Most participants made a distinction between the shady eastside path enhanced with art, sitting places, and a neighborhood bulletin board vs. the obstructed and more barren westside path. Interesting architecture and neighbor interactions were also cited in positive responses.

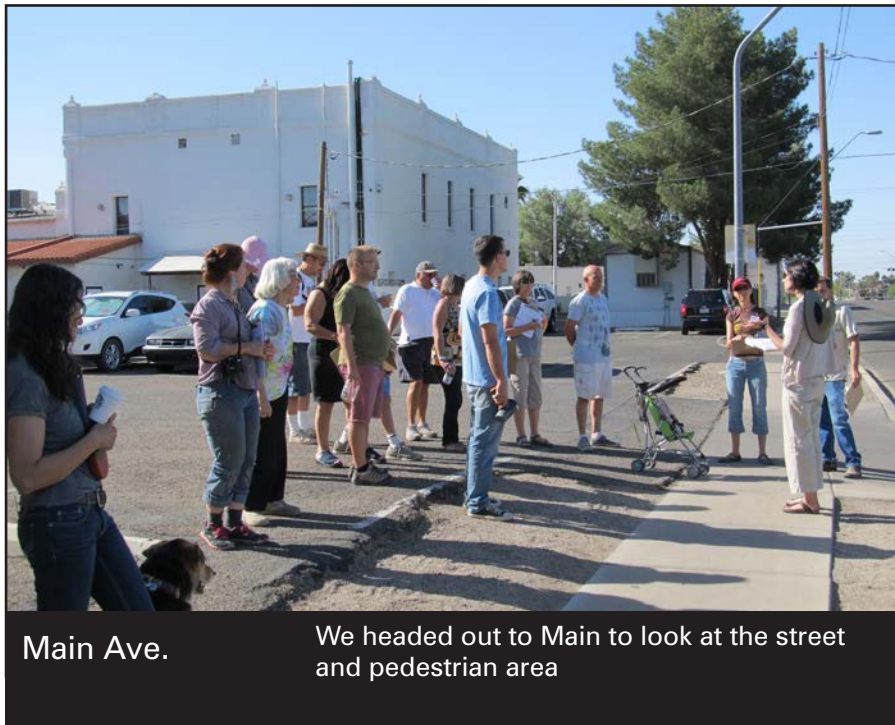
Map Point 2

Main Ave.

We headed out to Main to look at the street and pedestrian area

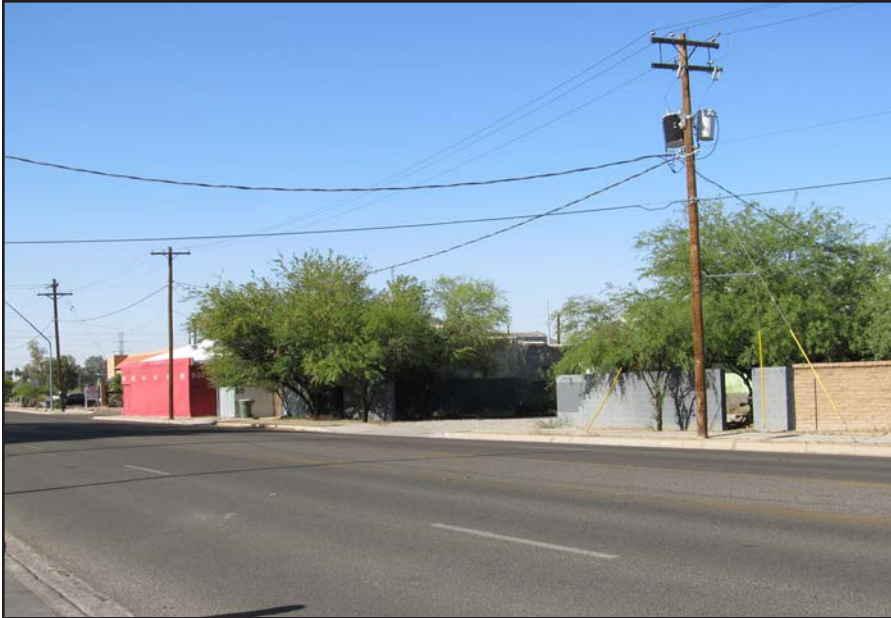
Map Point 3

Lots of
traffic lanes

On Main we talked about the potential for a “road diet,” better crossings, and maybe a median island. Some folks said cars cut through neighborhood here when they get stopped at the train.

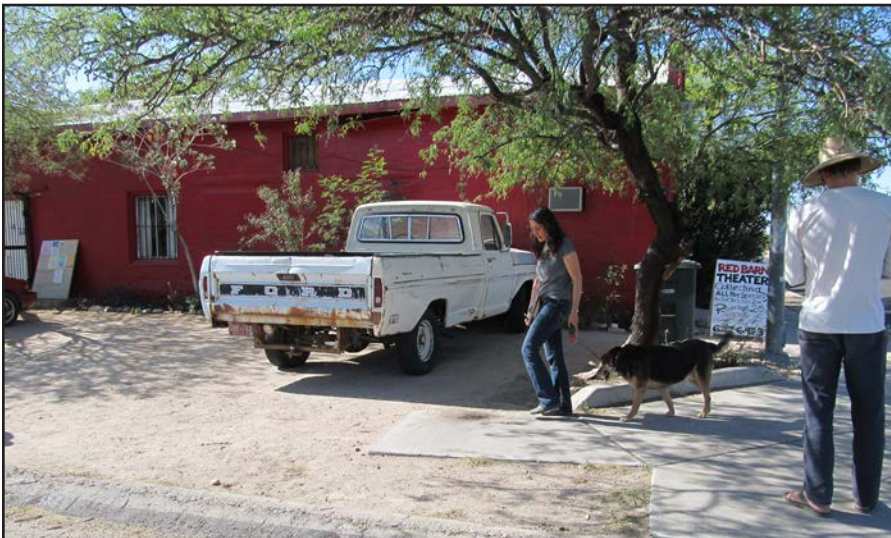
Map Point 4

Where the
sidewalk ends

As we turned onto 2nd street by the Red Barn Theater, the sidewalk disappeared

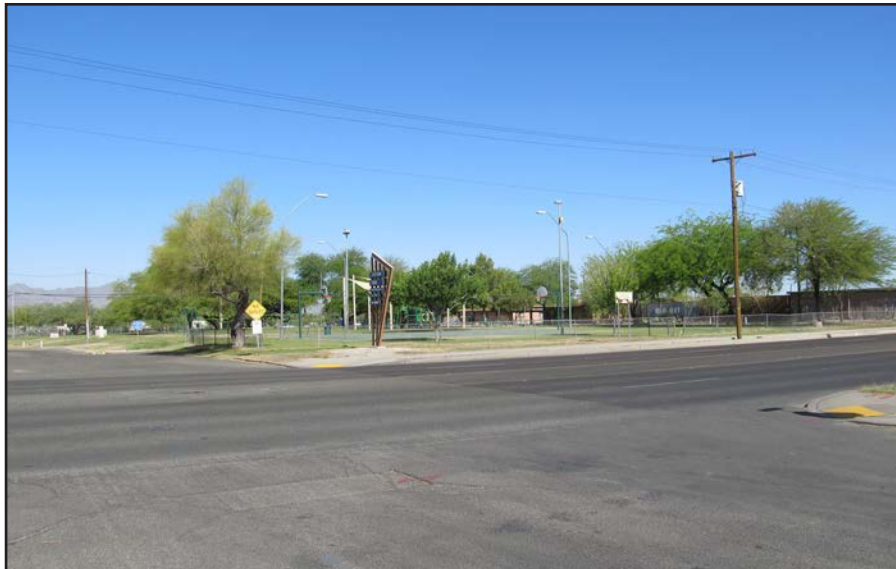
Map Point 5

Where the
sidewalk ends

As we turned onto 2nd street by the Red
Barn Theater, the sidewalk disappeared

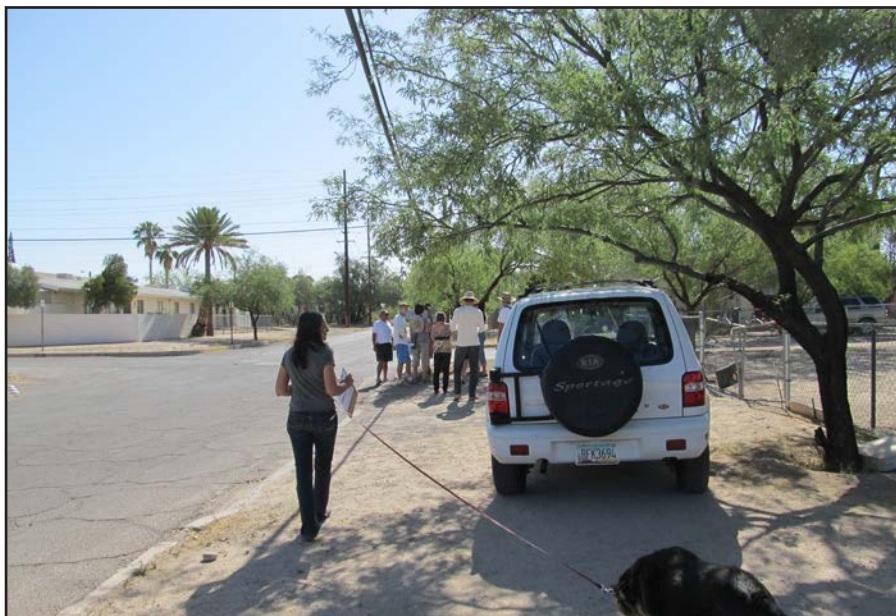
Map Point 6

Right of way?

This car parked off the street prompted a
discussion about right-of-way and property
lines - is it illegally parked?

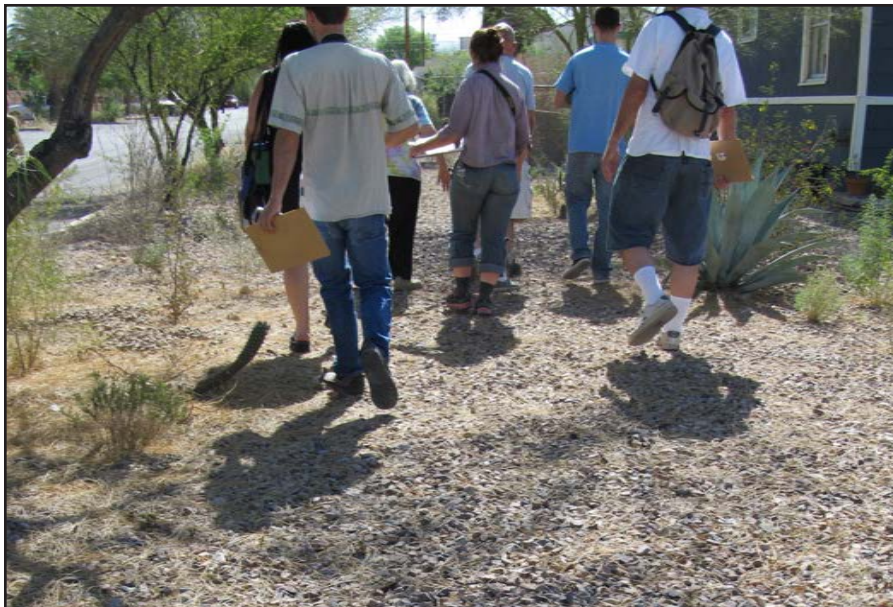
Map Point 7

Gravelly path

In several places throughout the neighborhood the right of way is gravelly and difficult to walk on

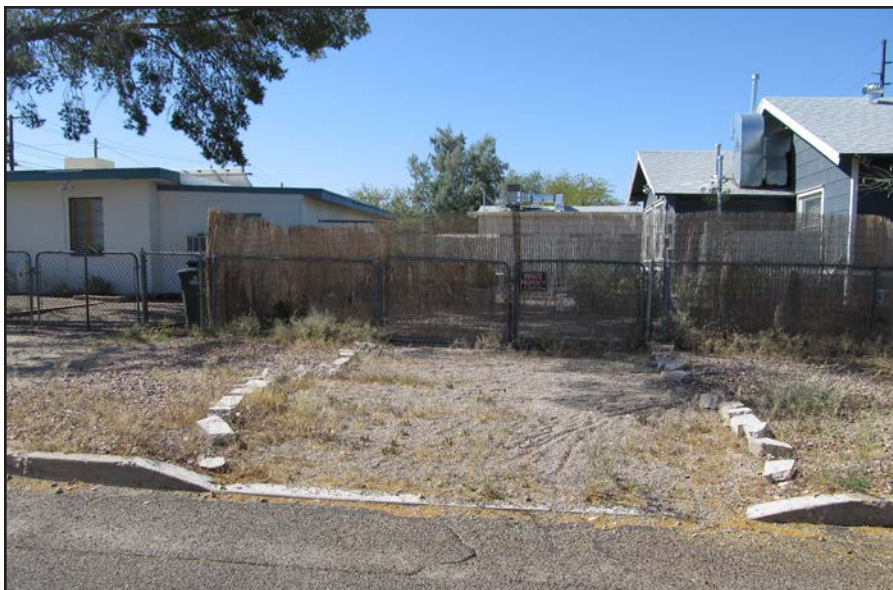
Map Point 8

Path is blocked

We discussed how neighbors can inadvertently block the walking path when putting in their own improvements

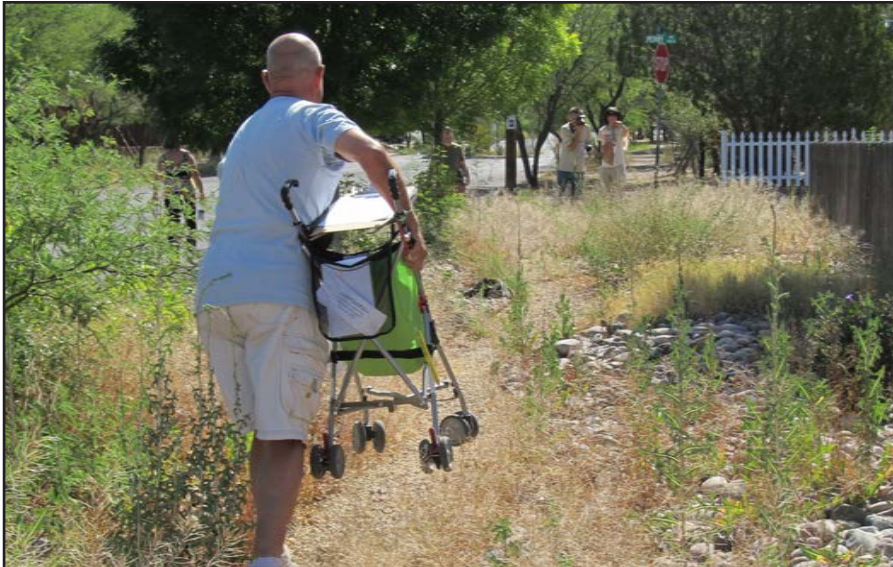
Map Point 9

Carry the stroller

One neighbor brought a stroller filled with rocks to demonstrate accessibility problems. Here he had to carry the stroller in order to stay off the street.

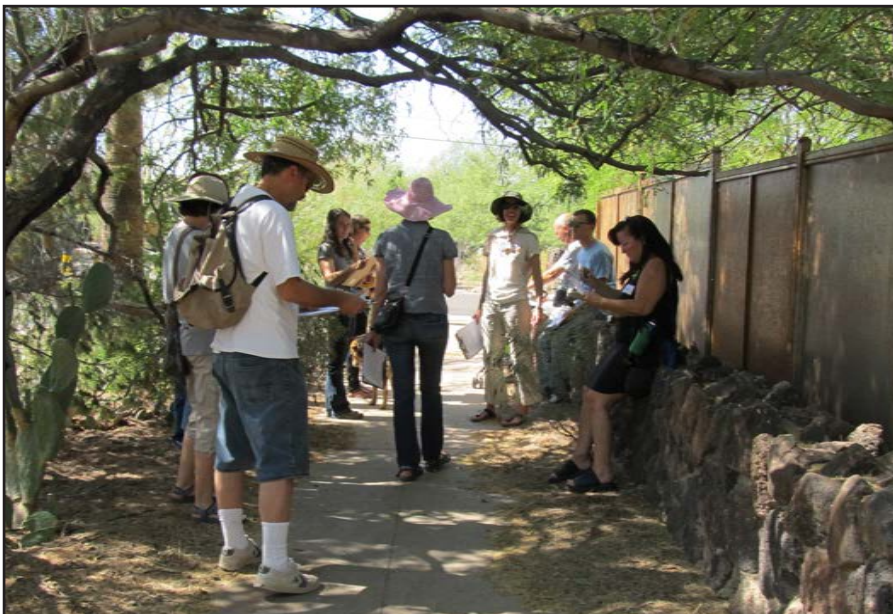
Map Point 10

Break time

Neighbors take a break on 9th Ave and discuss the pros and cons of fences like this (i.e. less “eyes on the street” vs. personal privacy)

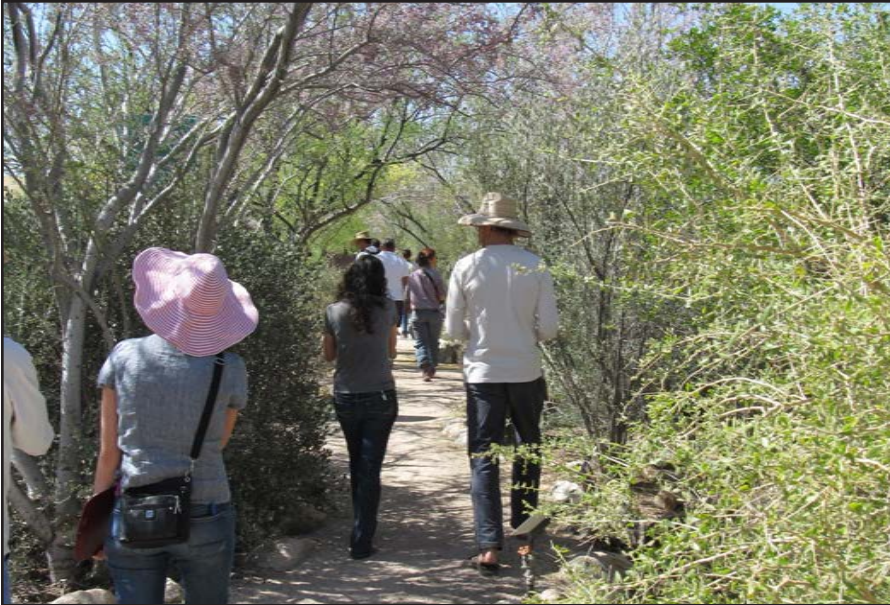
Map Point 11

Native plants

This house has planted extensively in the right-of-way with native plants utilizing passive water harvesting.

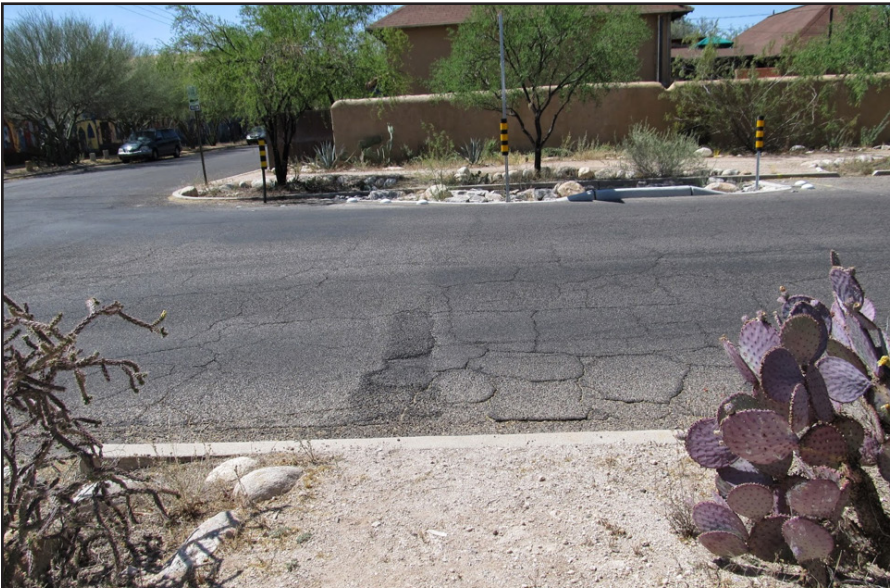
Map Point 12

Confusing crossing

Crossing University here can be confusing. The lovely path on the north side leads straight into the opposite chicane. Neighbors said this often pushes pedestrians into the vehicle zone around the traffic circle.

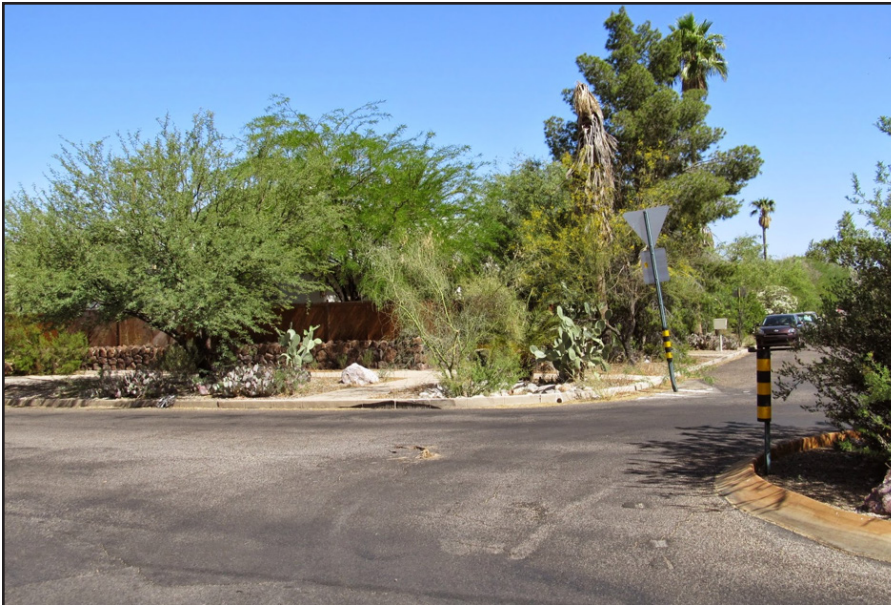
Map Point 13

Intersection improvements

Neighbors talked about some ideas to improve this intersection, including the addition of speed bumps and reconfiguring chicanes.

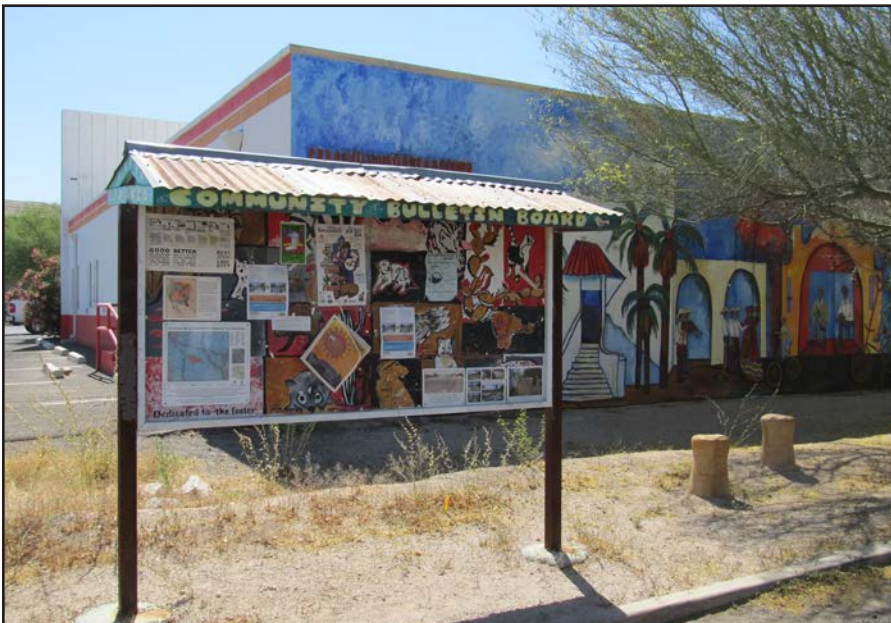
Map Point 14

Neighborhood asset

Neighbors talked about the benefit of amenities like this community billboard and the nearby Free Library

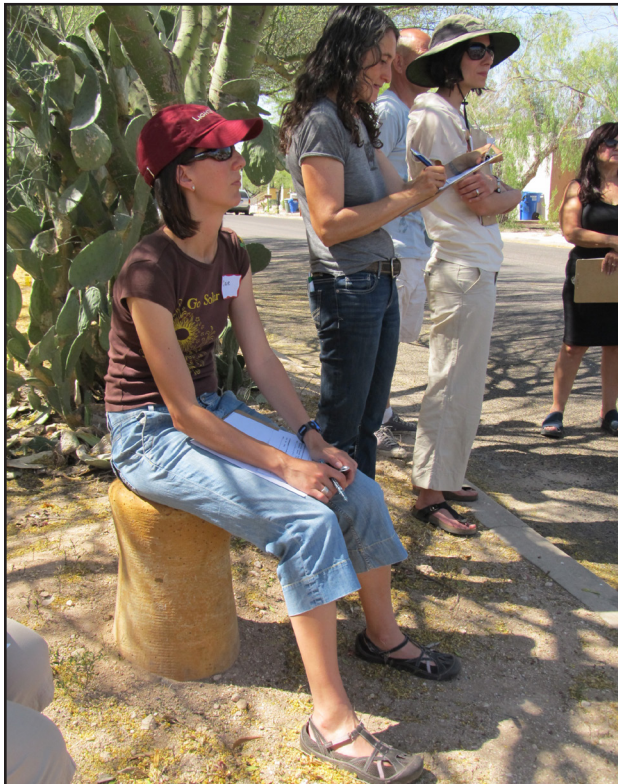
Map Point 15

Take a seat!

Street furniture makes for
a welcome break

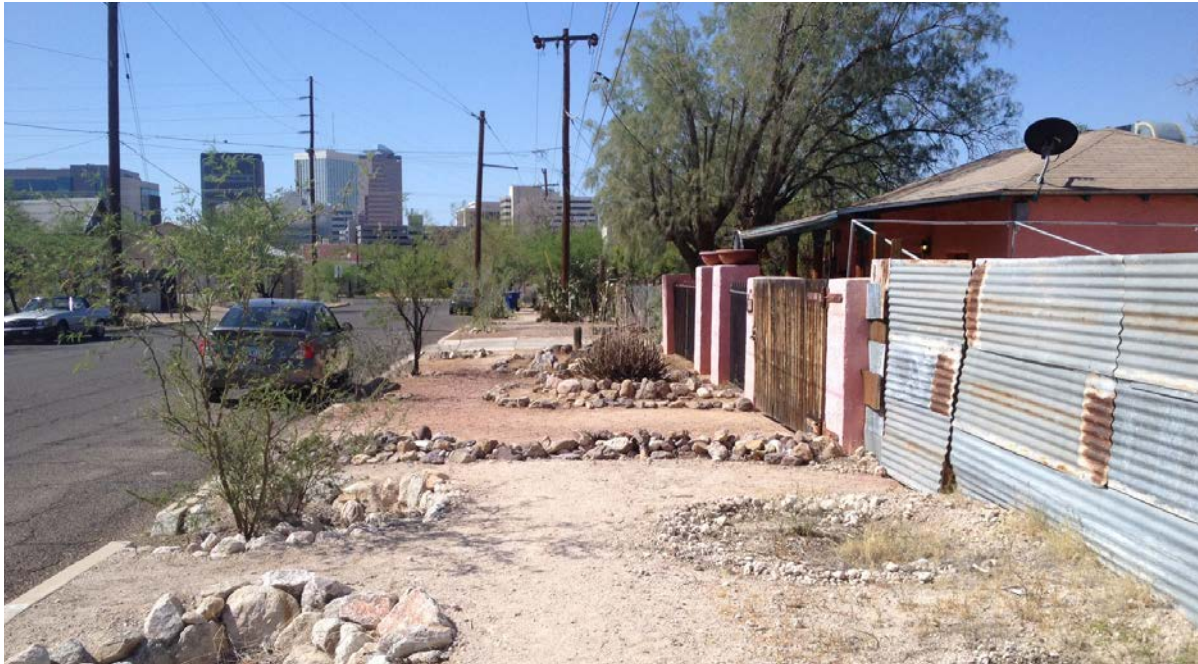
At 631 N. 9th Ave, rocks block path.
Rocks along path make it too narrow - only four feet wide.

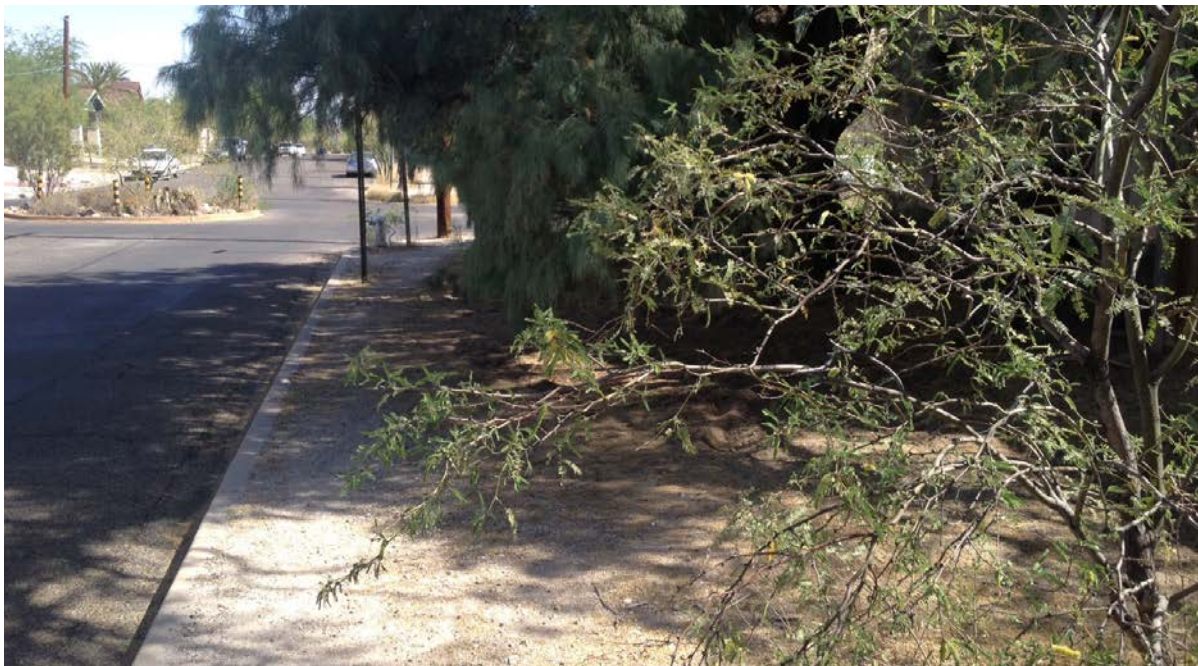
SE corner of 9th Avenue and 4th Street: a tamarisk tree offers great shade, but it needs to be pruned to make path clear for all. Less than six feet height of clearance. Less than four feet width.

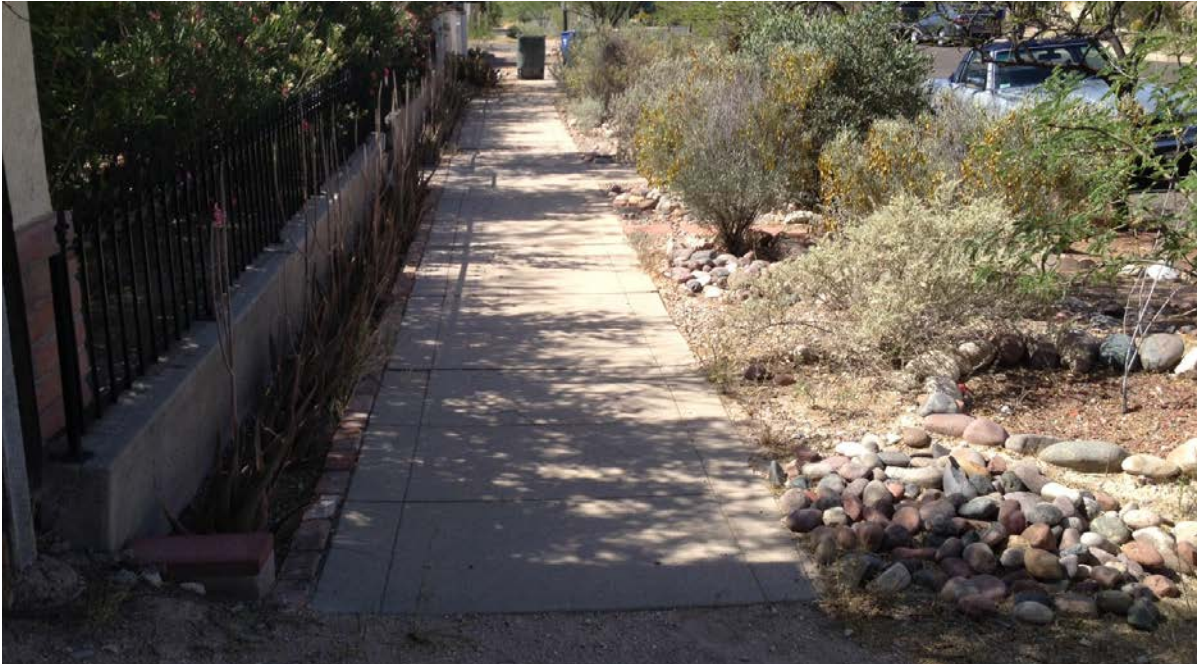
Only sidewalk is in front of 628 N 9th Avenue (historic home). Nice clear and wide. Over five feet wide. But it needs repair. Neighbors garbage cans at 618 N 9th Ave somewhat block path on south end.

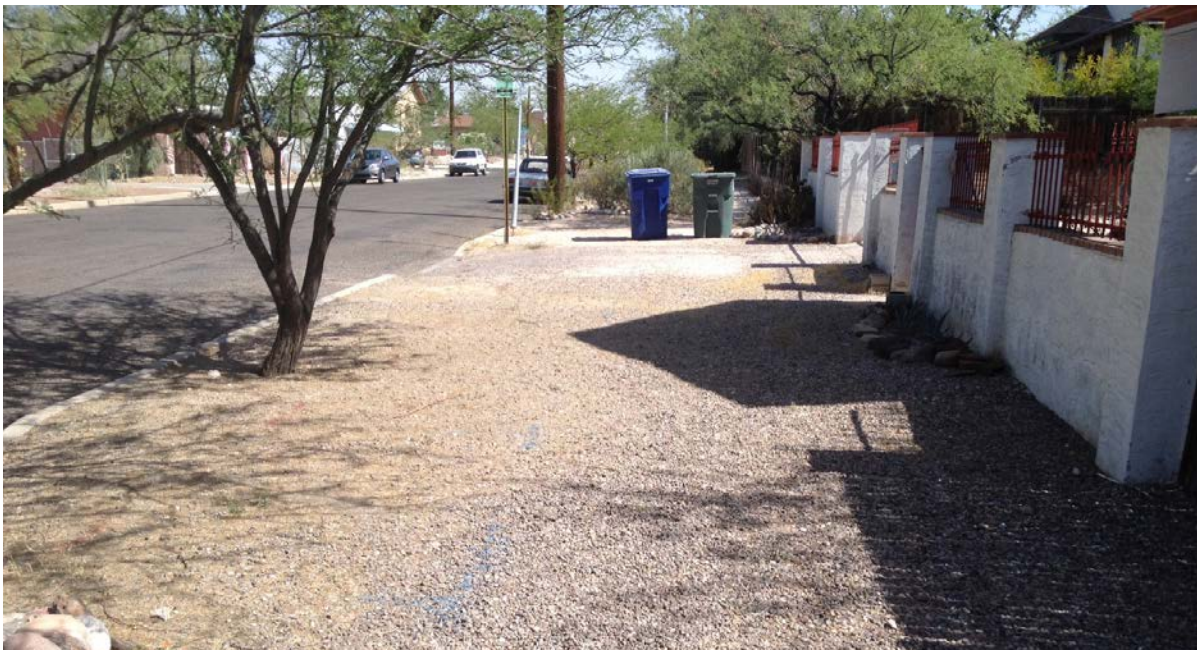
618 N 9th Avenue: there are two nice shade trees and room/need for another along street. Path is nice and clear, but gravel is hard to walk on. Garbage cans block pathway.

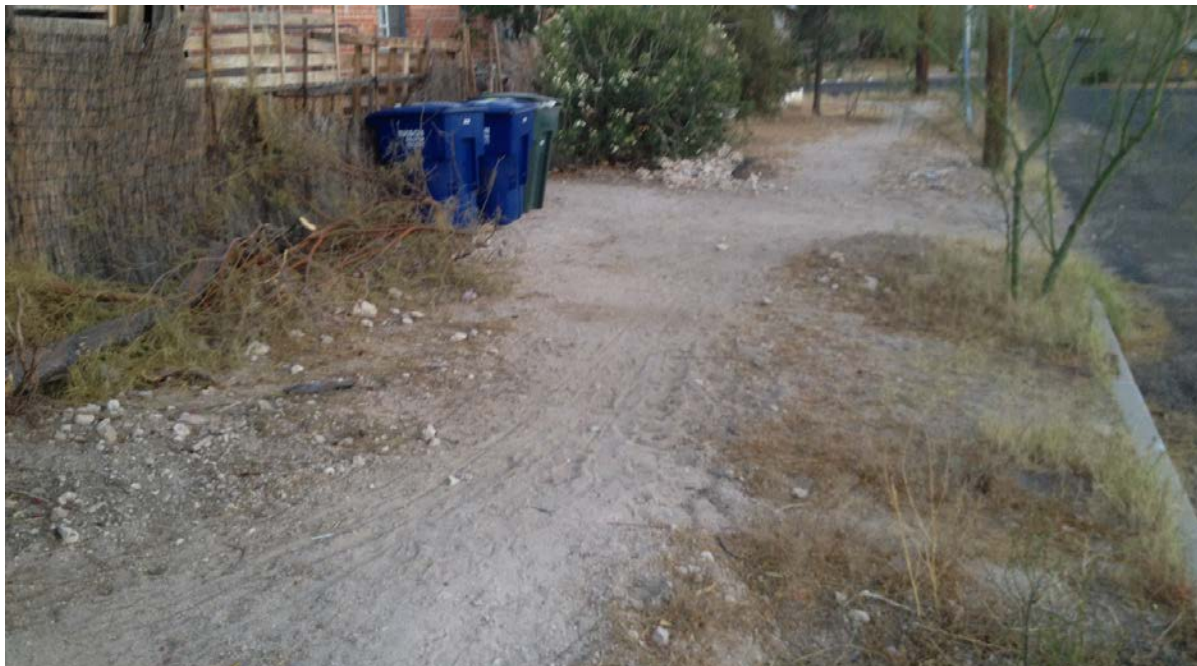
West of 48 W 4th Street along 9th Avenue: Caliche and dead branches debris often found along path. There are some newly planted shade trees, but more are needed. Pathway is clear.

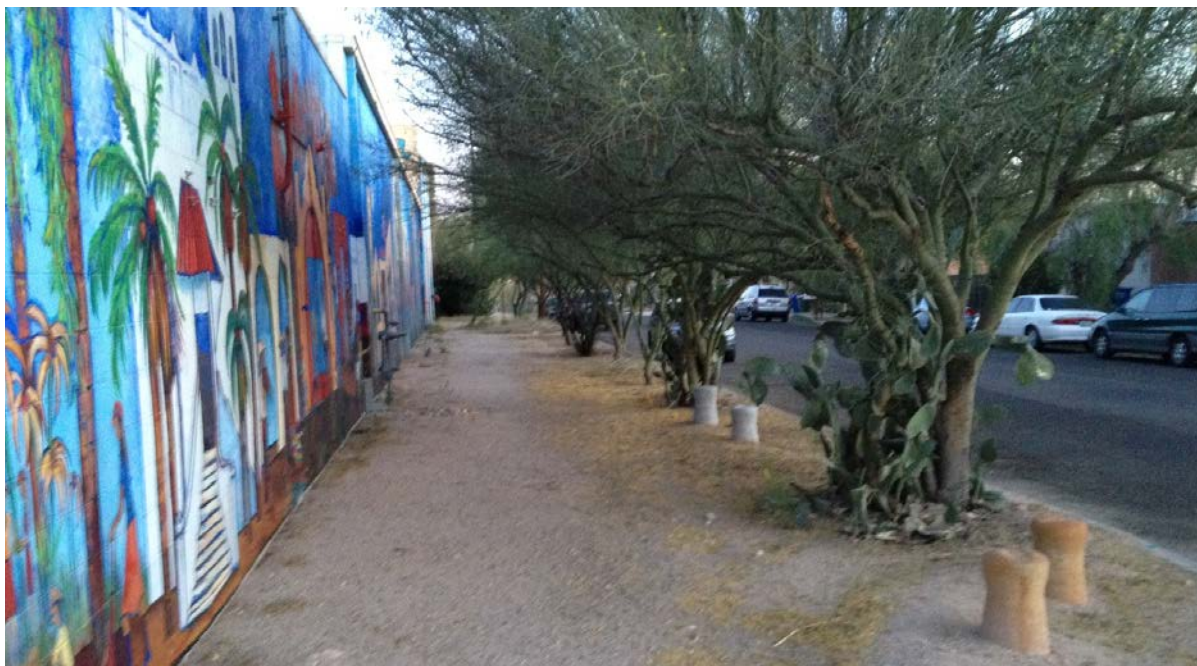
Fairly clear and well shaded path along mural on west (9th Avenue) side of Merle's auto at 33 W University.

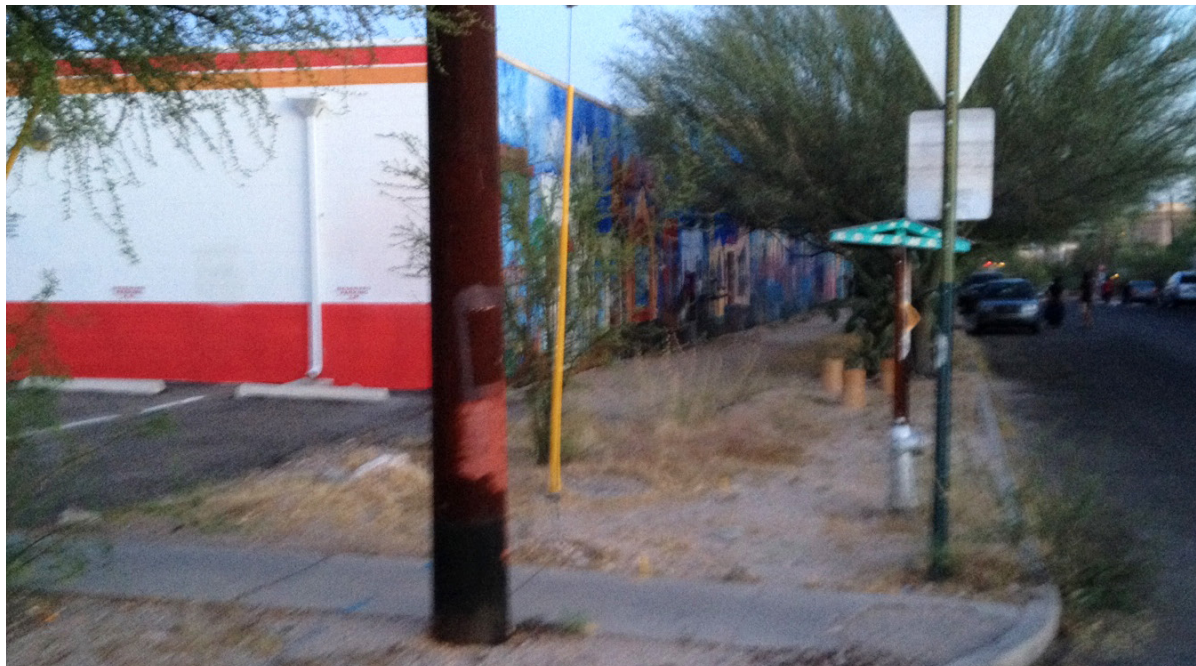
Access to path on west (9th ave) side of 33 W University is difficult (over berm and around plants.) Bulletin board and seats are nice.

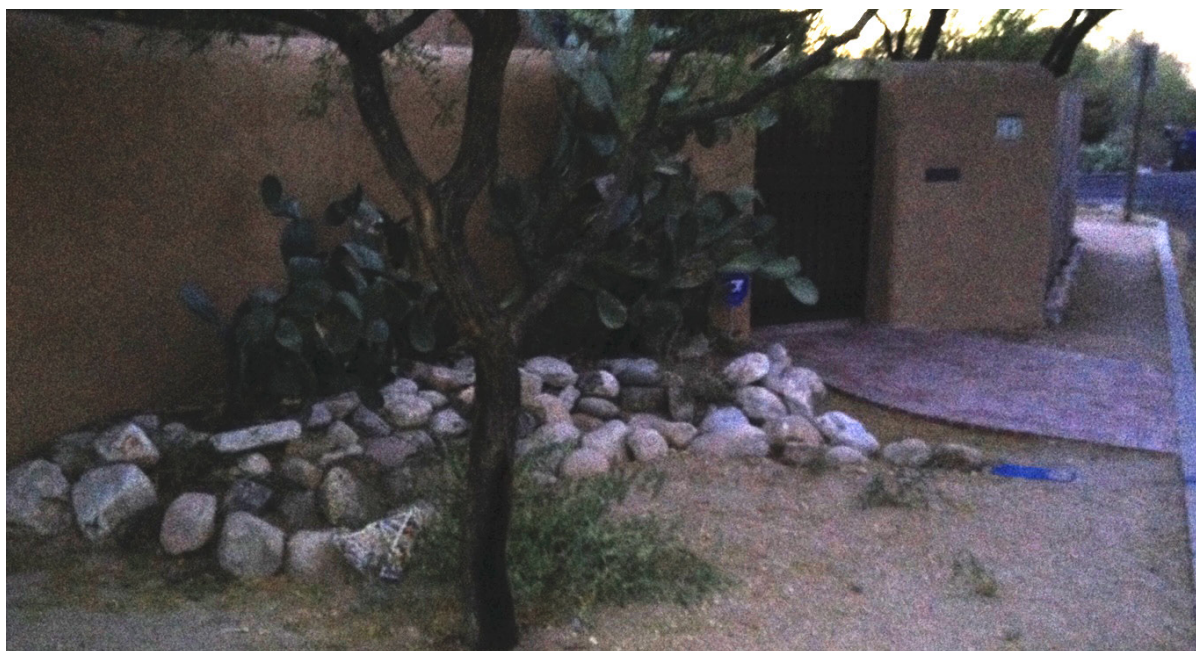
Trees are nice, but wall encroaching ROW reduces its width from twenty feet to just three feet.

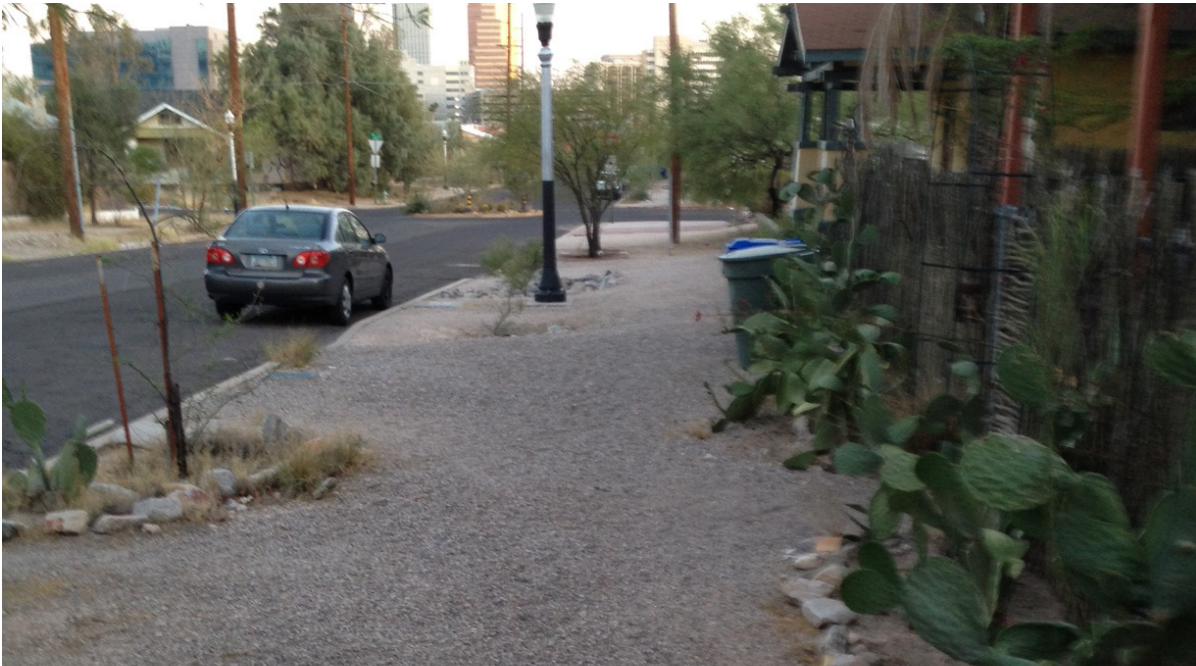
Gravel in walkway at 721 N 9th Ave makes walking or pushing stroller difficult.
Pathway is clear.

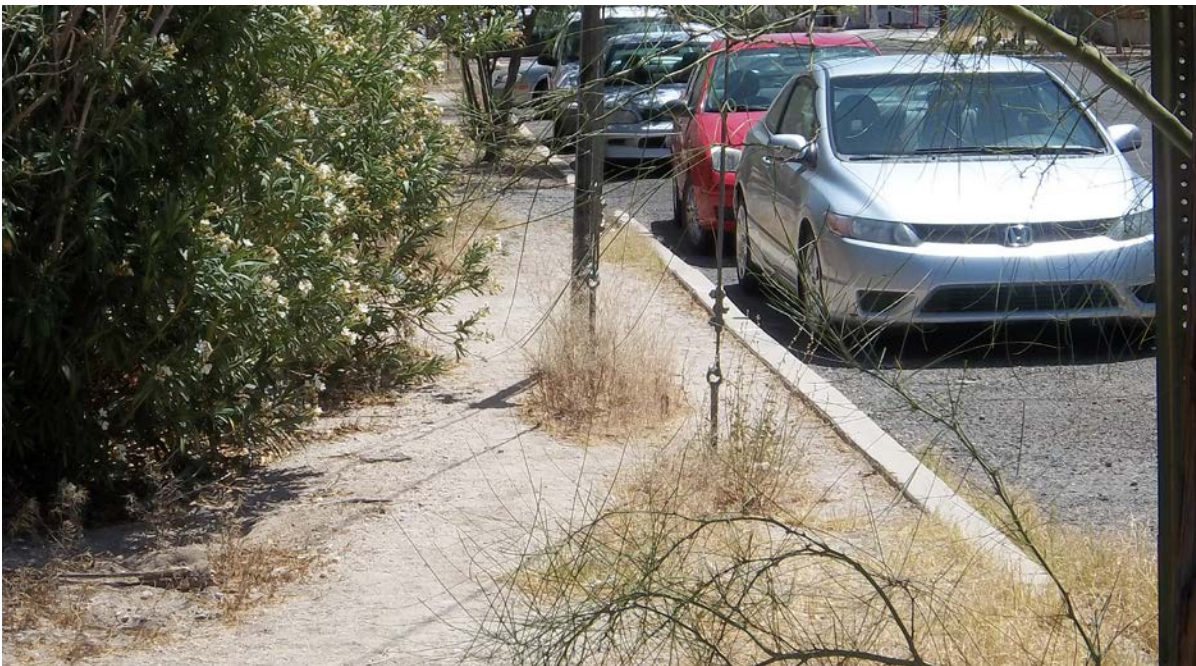
Impassable sidewalk due to vegetation on 5th Street east of 9th Avenue.

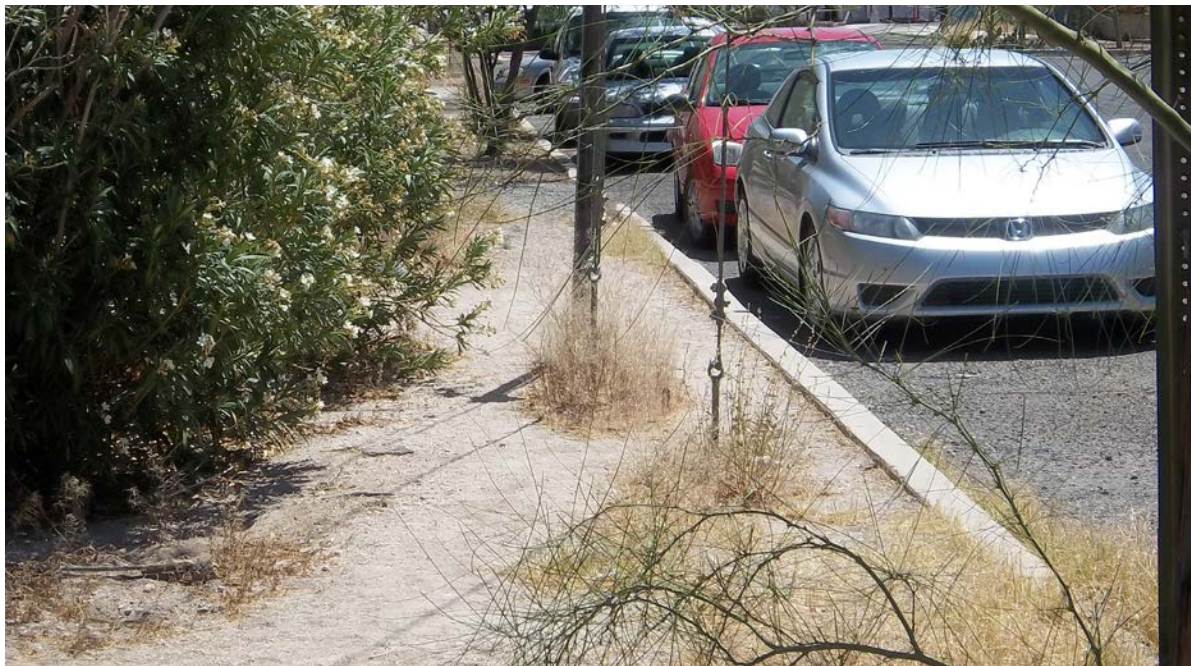
Impassable sidewalk due to vegetation on 5th Street east of 9th Avenue.

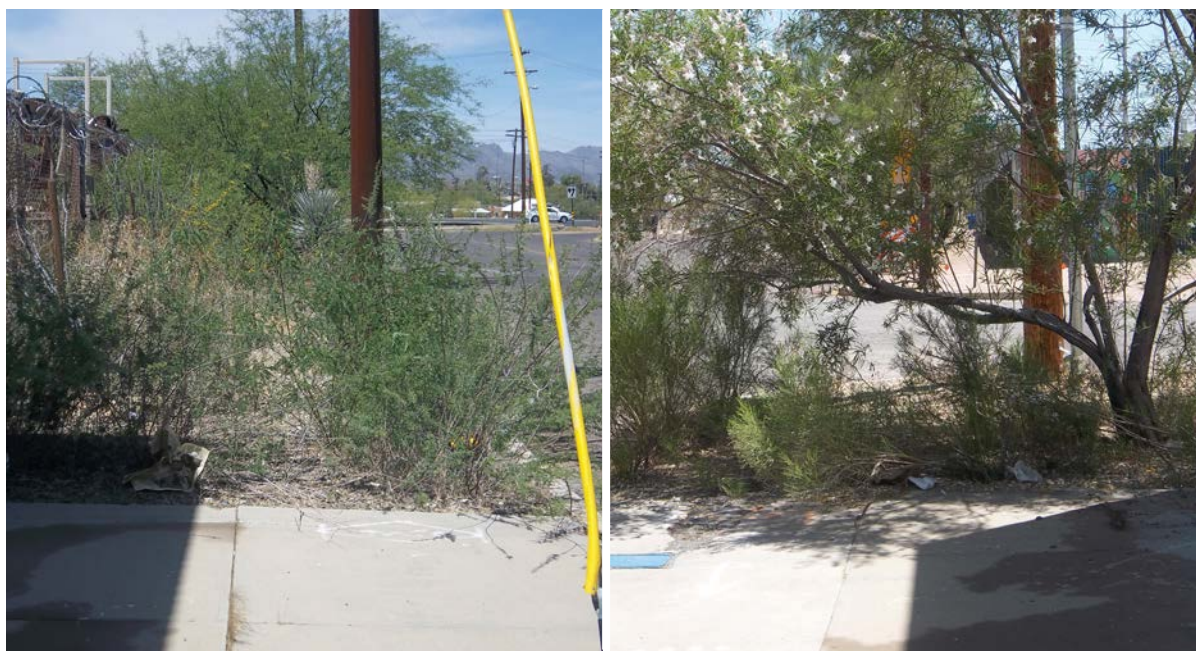
These two pictures show impassable sidewalks on both sides (north and south side) of the intersection of 4th Street and Alder Avenue making it impossible to get to Main Street.

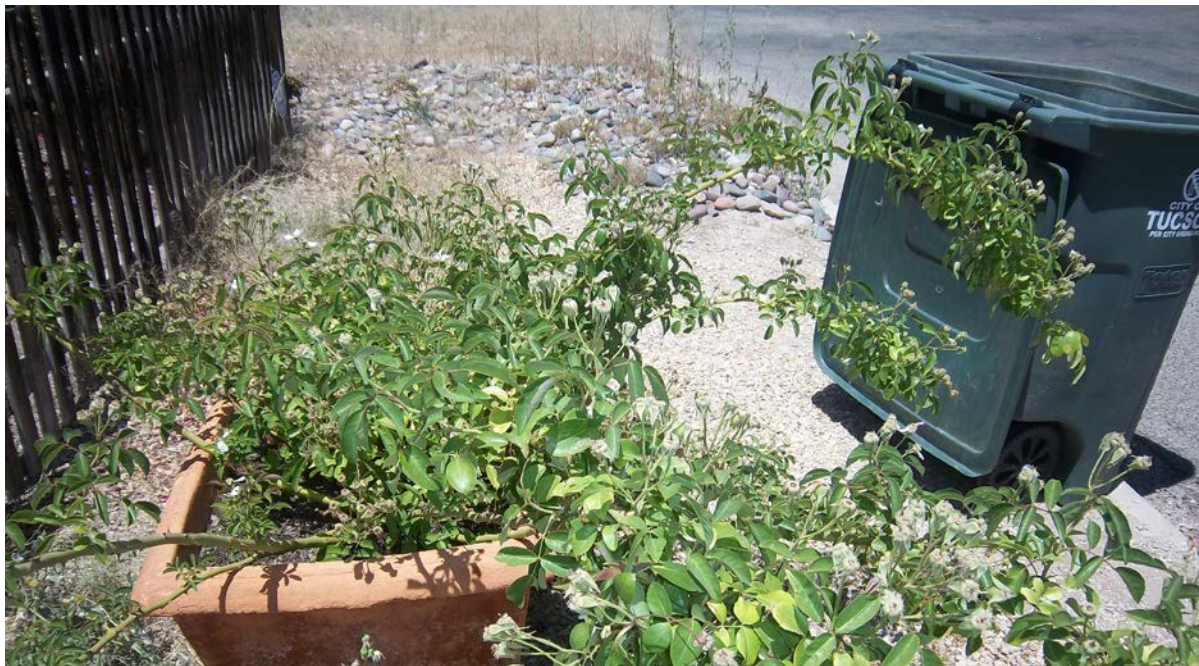
Impassable sidewalk on Perry Avenue south of 1st Street due to giant planter, vegetation, garbage can, and loose gravel followed by rock wall.
