Dunbar Spring Neighborhood Walkability Assessment Report

(August 2014)

WALK REPORT
2014

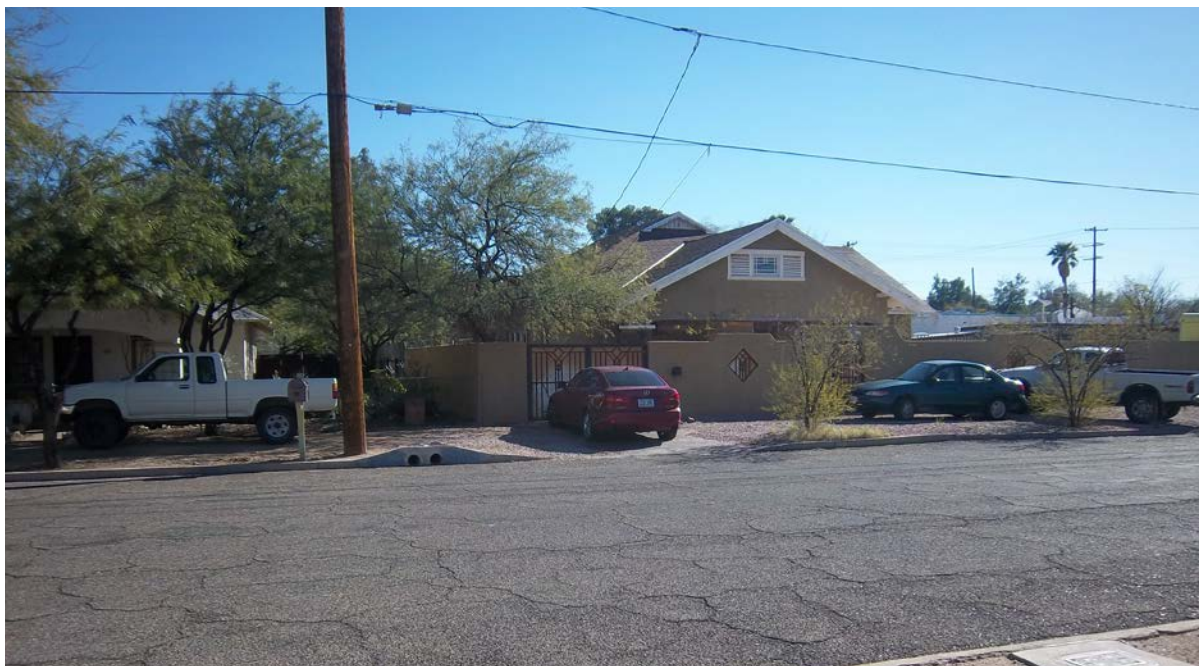
Cars blocking sidewalk on 11th Avenue.

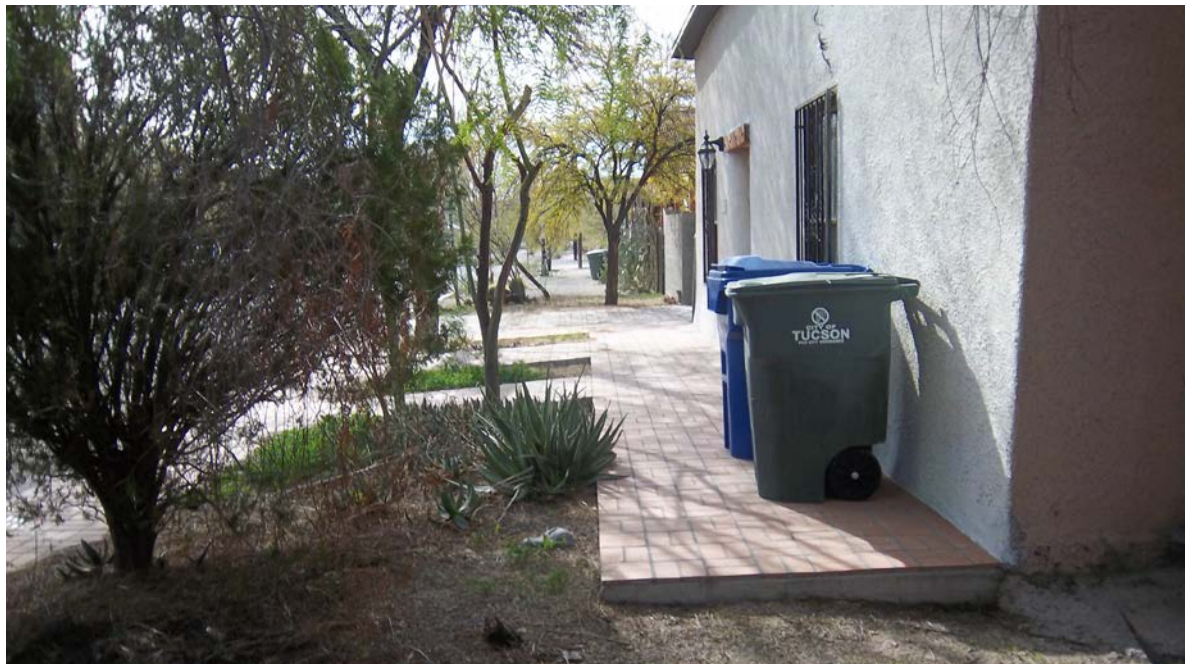
Garbage cans and step make navigating the sidewalk difficult on 9th Ave. south of University.

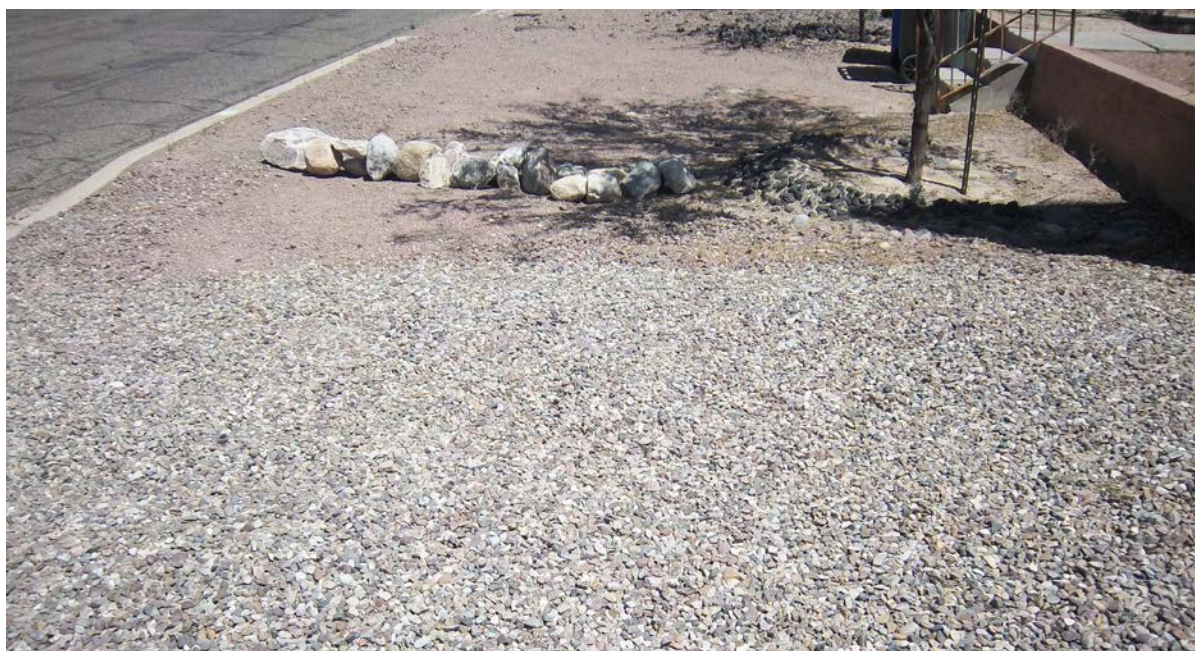
Impassable sidewalk on 11th Ave south of University Blvd. due to loose gravel and rock barrier.

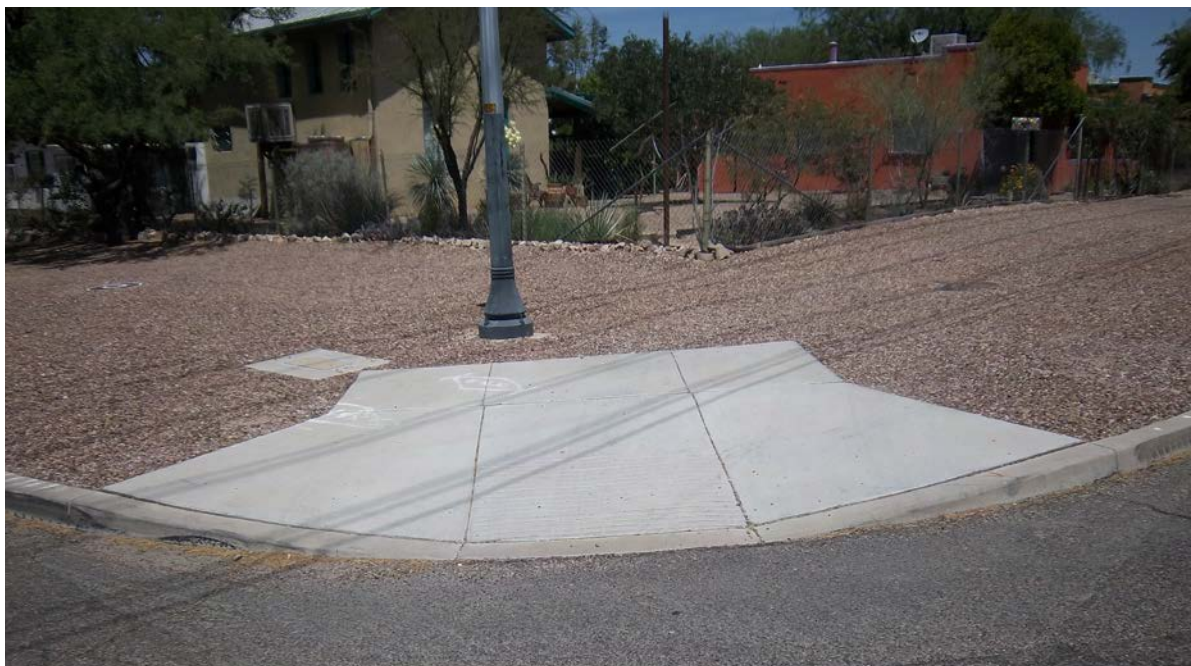
Handicapped access to nowhere due to loose gravel at 11th Ave. and 2nd Street. Pathway is clear.

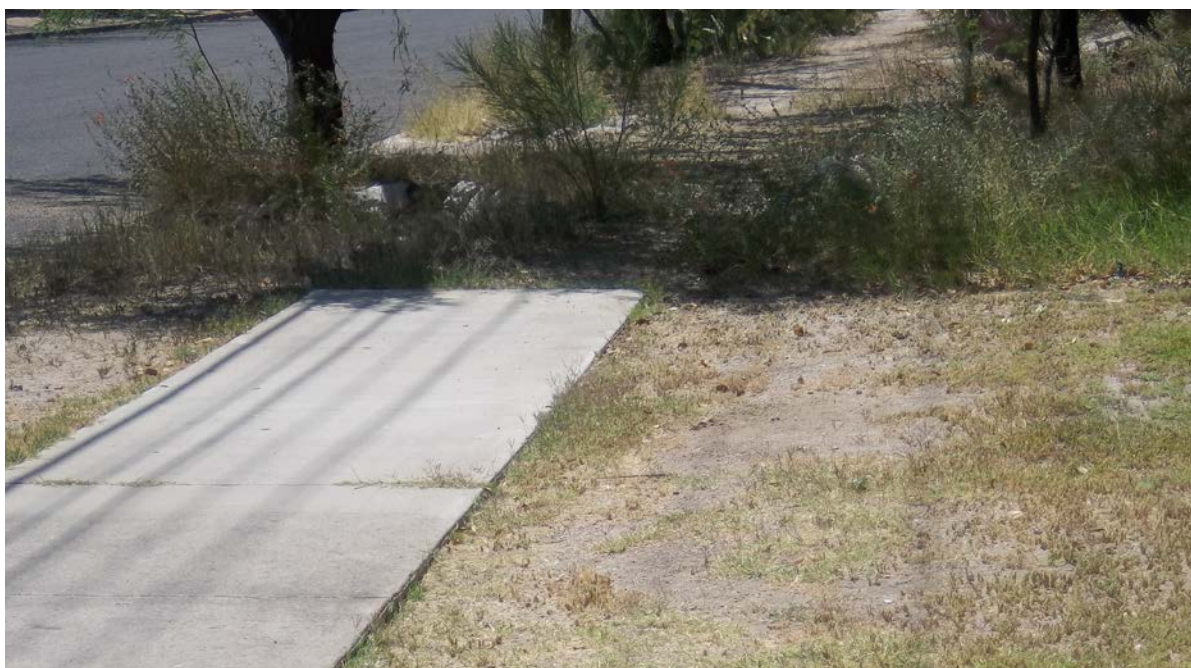
Sidewalk dead ends into vegetation on 11th Ave. south of 1st Street.
